Thermographic Inspection in a Modern Distribution Network: Case Study of Fokida

J. G. Fantidis^{1,*}, K. Karakoulidis¹, A. Tsara¹ and S. Sioutas²

²Hellenic Electricity Distribution Network Operator, Department Of Central Greece Region, Fokida Area, Greece

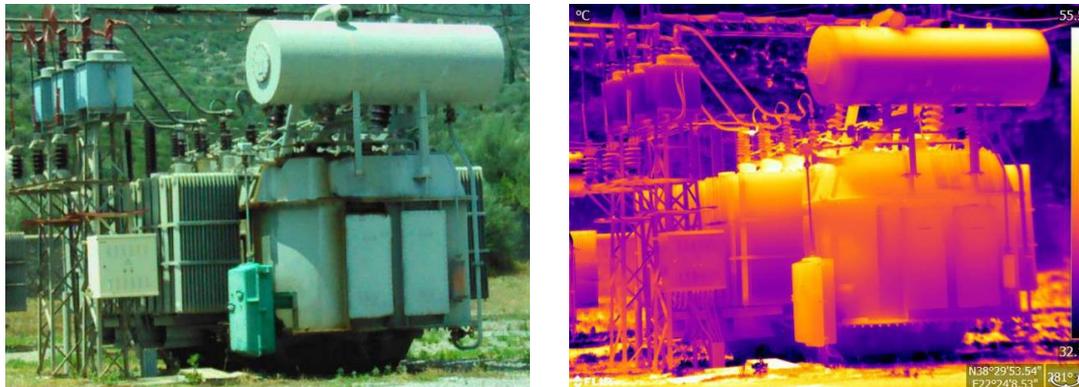
Fig. 2 shows a thermal image of a HV/MV transformer during the June midday heat when the transformer works nearly with the maximum load. With the thermograph we can find faults which are invisible with the SCADA system or with the human eyes such as loose, dirty or high resistance connections, problems in the bushings, improper oil levels and the cooling pattern of the transformer oil. There are numerous potential root causes for abnormal cooling pattern, such as low oil level, a closed valve or flow obstruction.

Fig 2. The visual photo and (left) the thermal photo of a HV/MV transformer (right).

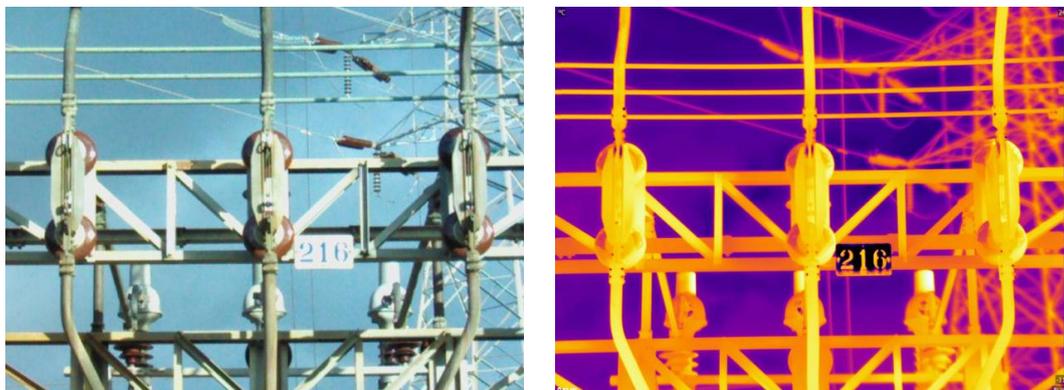
separation gap in the open position. Fig. 3 shows a picture of the three single phase busbar disconnectors while the fig. 4 presents a three single phase feeder disconnectors in this case usually examine the hinged joint of the knife in the disconnectors.

Fig 3. The visual photo (left) and the thermal photo of a three single phase busbar disconnectors (right)

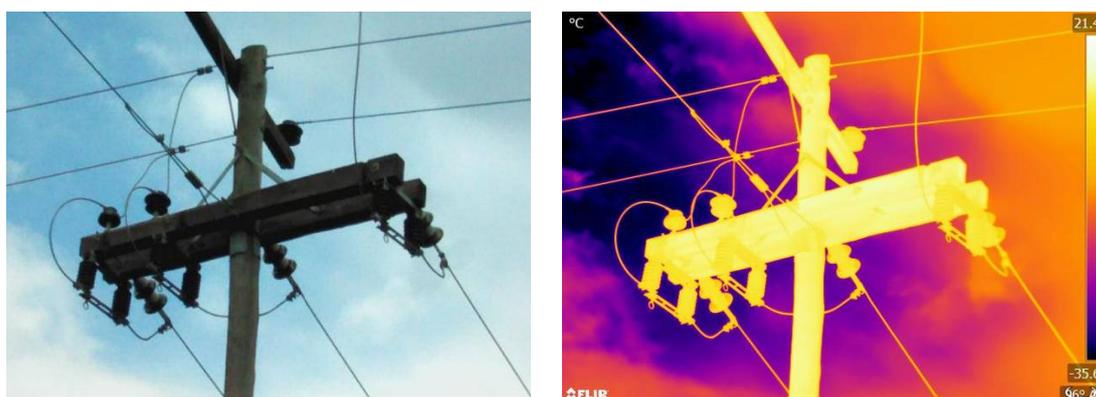
Fig 4. The optical photo (left) and the thermal photo of a three single phase feeder disconnectors (right).

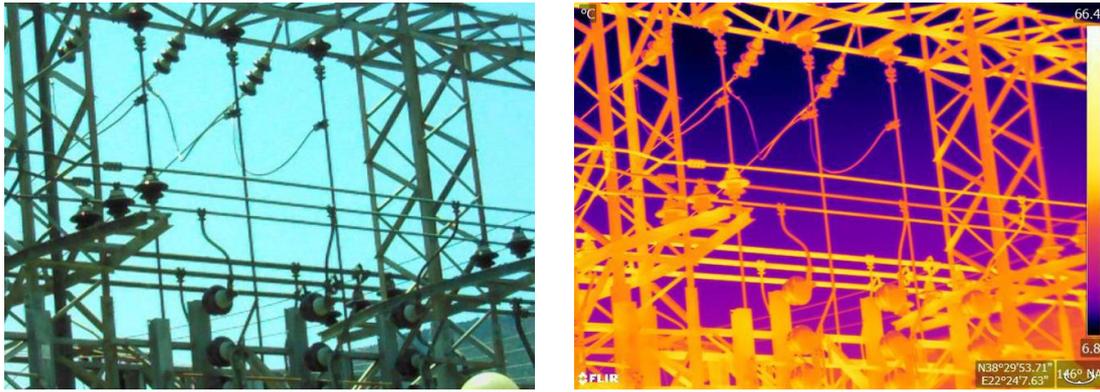
Busbars or buses are the backbone of the substation. Busbars are metallic tubes which used in order to carry large current and distribute it to multiple circuits within switchgear or equipment. With a thermal camera search mainly for strange objects or animals, usually snakes or ferrets (fig. 5). Load breaker switches, tele controlled load breaker switch and switch disconnectors inspected principally for poor or dirty connections (fig. 6).

Fig 5. The visual photo (left) and the thermal photo of a part of busbars in the Fokidas' HV/MV substation (right).

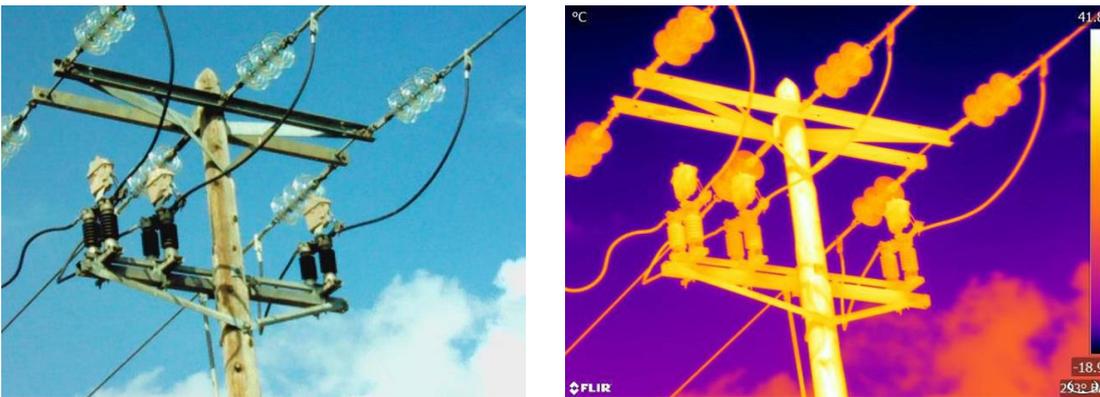
Fig 6. The optical photo (left) and the thermal photo of three Load breaker switches (right).

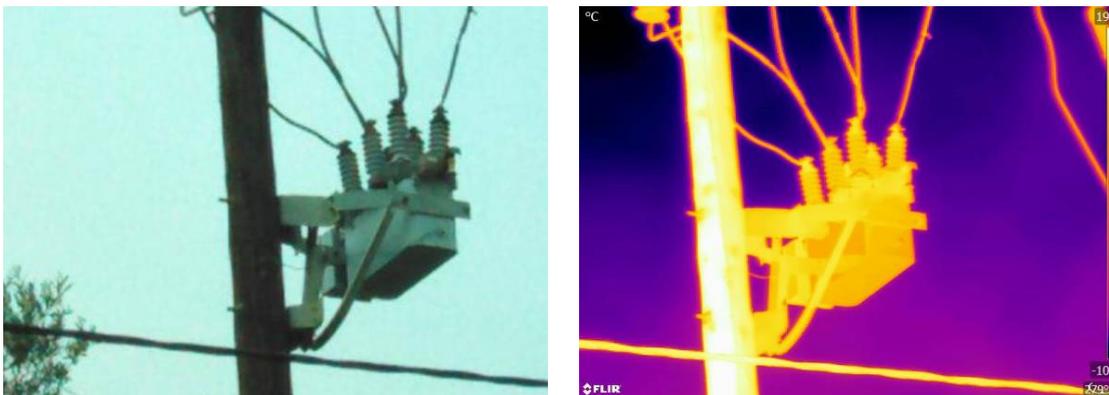
A sectionalizer is a self-contained, circuit-opening device that automatically isolates a faulted section of line from the rest of the distribution system. Both for single and three phase sectionalizers the most common problem is located on the connection between the top side of the bushing and end cap or in internal connections on the top side and the bottom side of the bushings (fig. 7).

Fig 7. The visual photo of a sectionalizer (left) the thermal photo of the same part (right).

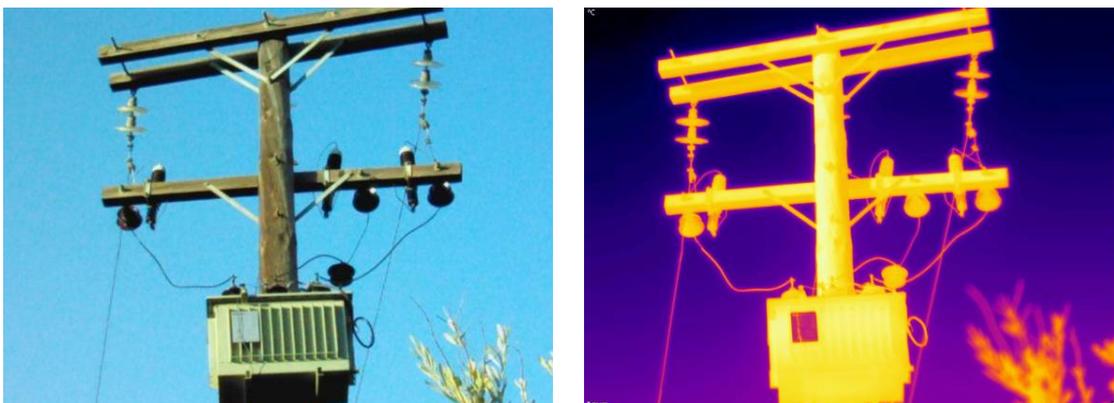
Surge arresters are devices which protect electrical equipment from over-voltage or surges caused by external (lightning) or internal (switching) events. Surge arresters can frequently be installed at the end of an overhead line or a cable. Fig. 8 shows the thermal and the visual image of three

surge arresters above in a MV/LV substation. Similar to a HV/MV power transformer in the case of MV/LV power transformer thermographer of the HEDNO inspect all the critical points of the transformer namely surge arresters, cooling system, tap changer tank and bushings.

Fig 8. The visual photo of 3 surge arresters in a MV/LV substation (left) and the correspondingly thermal photo (right).

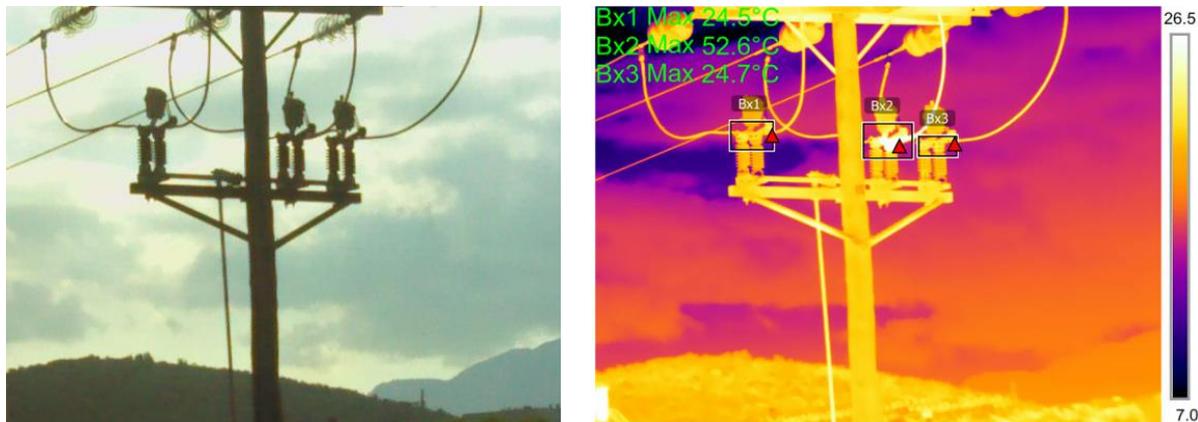
oil level is the top seal leaking, allowing water to enter and moved towards the bottom shifting the oil upward. However the most revealed problem in the inspection of a distribution network is a poor or dirty connection. Fig. 9 shows a poor connection in the second phase of a load breaker switch with priority 1 according to NETA Maintenance Testing Specifications.

Fig 9. A visual image of a load breaker switch (left) and the thermal photo which reveals a poor connection in the second phase (right).

Priority	Temperature difference (ΔT) based on comparisons between similar components under similar loading	Temperature difference (ΔT) based upon comparisons between component and ambient air temperatures	Recommended action
4	1°C – 3°C	1°C – 10°C	Possible deficiency, monitor and repair when possible
3	4°C – 15°C	11°C – 20°C	Probable deficiency, investigate further and repair when possible
2	-----	21°C – 40°C	Deficiency repair at next opportunity
1	> 15°C	> 40°C	Major deficiency, repair immediately

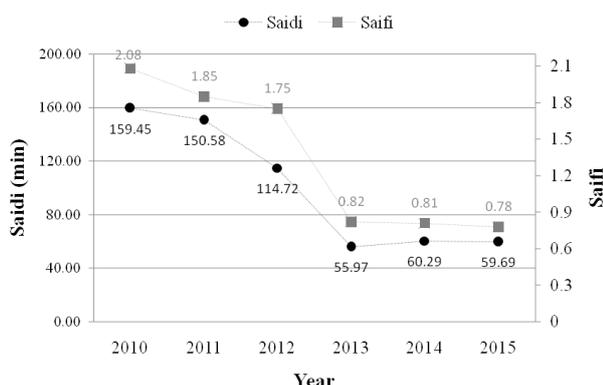
Fig 10. SAIDI and SAIFI indices during 2010 - 2015 in Fokida area.

However, the critical question is how the SCADA system, the tele controlled switches and the thermographical inspections meliorate the reliability of a distribution network. In the case of Amfissa the fig. 10 shows that two most common indices SAIDI and SAIFI improved by 62.6% and 62.5% respectively (during 2010 - 2015).
