Journal of Engineering Science and Technology Review 14 (6) (2021) 35 - 42

Accident Analysis of the Roadway Rockburst in Tangshan Coal Mine of China

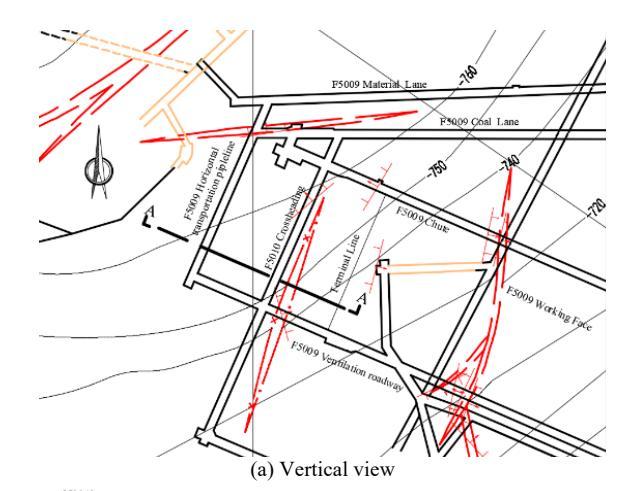
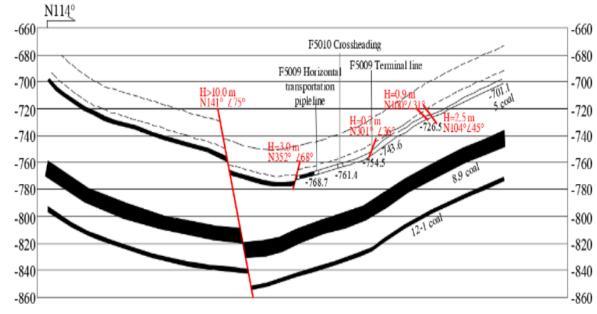
(b) Sectional view of A-A Fig. 2. Vertical and sectional view of the region of "8.2" accident.

At 12:24 on August 2, 2019, a large rockburst accident occurred in the crossheading F5010 and the horizontal transportation pipeline F5009 in the coal pillar area of the ventilation shaft, and 7 deaths were caused. The vertical and cross-sectional views of the accident area are shown in Fig. 2. The coalmine operation center received a report from the underground that a rockburst accident occurred, and the rescue team was urgently organized to the accident location. Subsequently, other technical personnel were organized to the scene of the accident for rescue. At 20:05 of the same day, the trapped persons were discovered and lifted out of the underground, during which no further disaster occurred.

The working face F5010 is located in the coal pillar area of the ventilation shaft, the east side is belt roadway T2150, the west side is the mined-out area No. 3654, the south side are T2155, T2154, T2153, T2152 goafs, and the north side is the working face under mining F5009 and the subsidiary headgates, with ground elevation of +12.6 m to +16.6 m. The crossheading F5010 has a total length of 178 m, connecting ventilation roadway F5010, the chute F5009, ventilation roadway F5009 and the subsidiary headgate. It is tunneled along the roof of the coal seam No. 5 with an average inclination of 12°. Bolt-mesh support was adopted for support. Both the top bolt and the side bolt used the right-threaded equal-strength rebar bolt with a diameter of 20 mm and a length of 2200 mm. The top bolting spacing was 700 mm to 800 mm, and the row spacing is 800 mm. The side bolting spacing was 800 mm with a row spacing of 800 mm to 1000 m. The cable bolt was the high-strength low-relaxation pre-stressed steel wire with a diameter of 17.8 mm and a length of 6500 mm. The mesh adopted a $12^{\#}$ diamond-shaped lead wire.

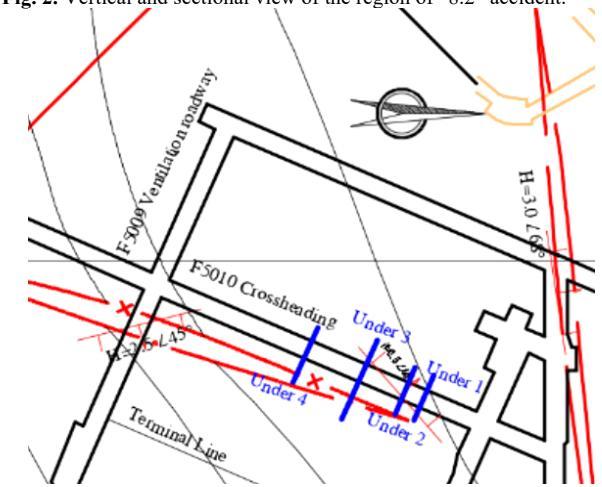
Fig. 3. Sketch of the damaged roadway location.

After the rockburst, the crossheading F5010 was sitesurveyed and Fig. 3 illustrates the roadway damage.

The accident caused the deformation of the crossheading F5010 over a length of about 80 m, of which the serious damage zone has a length of 30 m. The roadway side and floor were apparently damaged. The lower side of the roadway moved into the roadway by about 0.5 m to 2.0 m, and the upper side of the roadway was slightly damaged without obvious movement. The roadway floor was obviously damaged, and was broken near the upper side in the roadway center. The floor heave was 1.0 m to 2.5 m. From the damaged floor rock, the floor was a multi-layer composite structure.

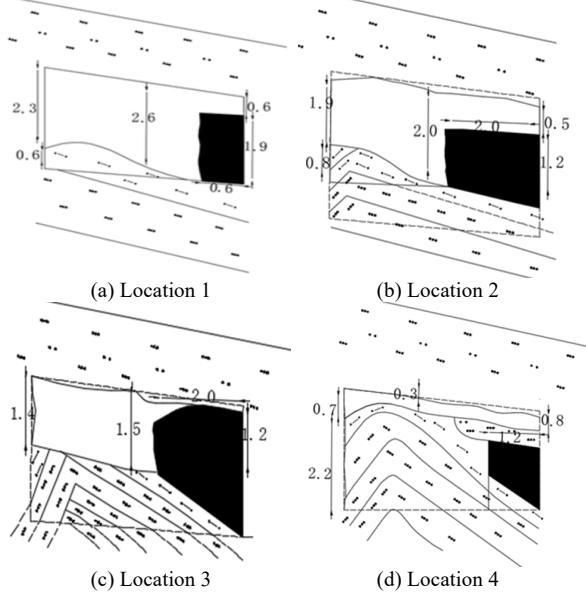
Fig. 4. Damage location of the crossheading F5010.

At the location of 32.1 m upper to the lower section of crossheading F5010 (Location 1 in Fig. 4a), the height of the roadway middle was 2.6 m, the height of the upper side was 2.3 m, and the remaining height of the lower side was 0.6 m. The lower coal wall moves inside to the roadway by about 0.6 m. Floor heave occurred on the upper side (Fig. 4a).

At the location of 36.8 m up to the lower section of crossheading F5010 (Location 2 in Fig. 4a), the height of the roadway middle was 2 m, the height of the lower side was 0.5 m, the coal wall was offset to the roadway inside by about 2 m, and the height of the upper side was 1.9 m. The support steel at the roadway top was deformed to some extent (Fig. 4b).

At the location of 47.2 m up to the lower section of crossheading F5010 (Location 3 in Fig. 4a), and the height of the roadway middle was 1.5 m. The lower coal wall was offset 2 m inside the roadway, resulting in a complete close of the roadway within 1 m of the lower side, and the upper roadway height was 1.4 m (Fig. 4c).

At the location of 61.3 m up to the lower section of crossheading F5010 (Location 4 in Fig. 4a), the height of the upper side was 0.7 m, and the minimum roadway height at a distance of 1.1 m away from the upper side was 0.3 m. The upper coal wall was offset by 1.2 m inside the roadway (Fig. 4d).

Fig. 4 shows that the damage in the middle of the crossheading F5010 was the heaviest. The roadway cross-section was basically closed, and the roadway failure mode was mainly dominated by the sliding damage of the roadway side coal, accompanied by the coal rushed out from the floor damage. The accident site has complex geological structure with high tectonic stress. The measured maximum horizontal stress of Tangshan Coalmine is 29.5 MPa to 33.0 MPa, and the lateral pressure coefficient is 1.38 to 1.60, which belongs to the high in-situ stress level. Five main faults are arranged sequentially within the coalfield. The accident site is near the largest southern boundary fault FV in the coalfield.

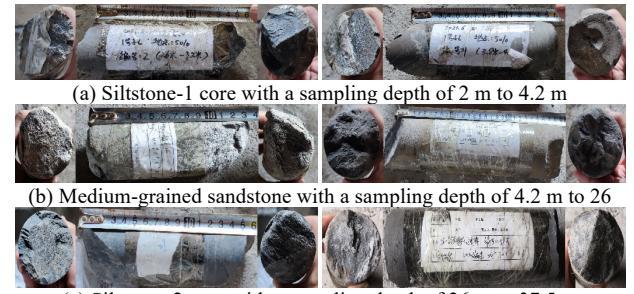
(c) Siltstone-2 core with a sampling depth of 26 m to 37.5 m **Fig. 6.** Cores of three lithology.

A total of 41 rock cores were taken out, two of which were unlabeled and thus their lithology and depth could not be determined. According to the core labeling, three layers of roof were exposed, among which two layers were marked as siltstone and one layer was marked as medium-grained sandstone. See Table 1 for more details.

To distinguish the two layers of siltstone, according to the sampling depth, the shallow one was denoted Siltstone-1, and the deep one was termed Siltstone-2. Core labeling shows that the initial sampling depth was 2m, and the final depth was 37.5 m. Part of the cores are shown in Fig. 6.

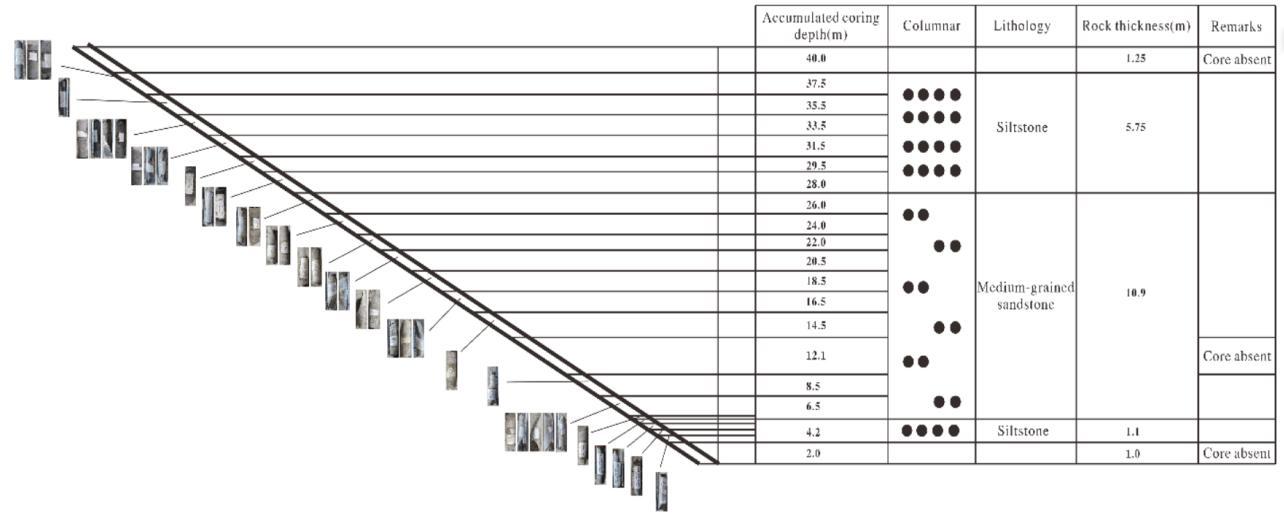
Fig. 7. Histogram of the roof under coring.

arranged according to the labelled depth, and the sampling histogram is drawn in Fig. 7. According to the histogram, the three rock layers overlying the coal seam No. 5 in the coal pillar area of the ventilation shaft of Tangshan Coal Mine are all sandstones, namely, the immediate roof is siltstone with a thickness of about 2.1 m; the basic roof is medium-grained sandstone with a thickness of about 10.9 m; and the upper part is siltstone with a thickness no less than 7 m.

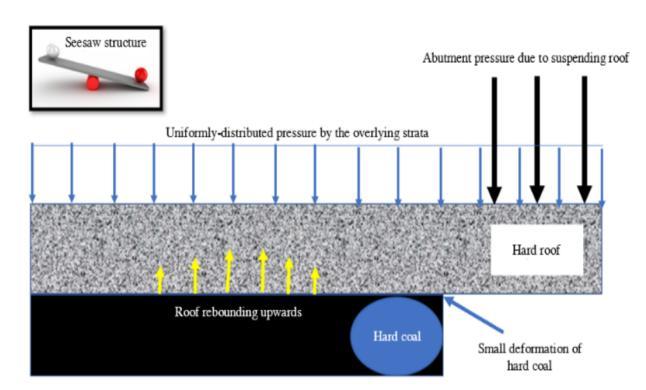
Fig. 10. Hard roof and hard coal form a seesaw structure.

Although the suspended roof behind the working face produces high abutment pressure, the coal near the working face owes high bearing capacity. The consequence of the interaction is that the roof above the working face rebounds upwards. The corresponding mechanism is shown in Fig. 10.

The blue arrow in Fig. 10 represents the gravity of the overlying strata. The suspended roof generated by the hard roof over mining leads to a formation of a cantilever beam structure, and the generated abutment pressure is denoted by the black arrow. The coal near the working face has high load-bearing capacity, and the deformation of the coal seam in the vertical direction is small, which will inevitably cause the roof above the working face to rebound upwards, as illustrated by the yellow arrow in Fig. 10. Generally, a structure similar to a seesaw is formed in the working face. The coal near the working face is the fulcrum, and the roof near the fulcrum is the compressing plate. The abutment pressure behind the working face acting on the suspended roof causes the roof to move upward in front of the working face (Fig. 10).

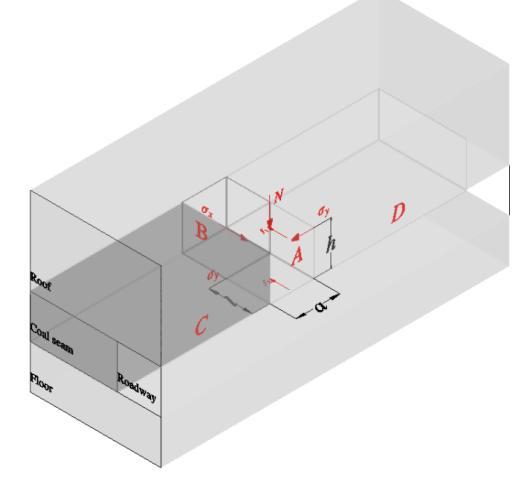
Fig. 11. Force equilibrium of the roadway side coal.

Assuming that both the roadway height and coal seam thickness are h, we take the coal block with a width of a along the roadway strike and the depth l at the roadway side as the study object, as shown in block A in Fig. 11. The coal block connected to block A along the roadway dip is denoted as block B, and the coal blocks connected along the roadway strike on both sides of block A are denoted as blocks C and D.

As mentioned above, the axis of the roadway at the accident site is almost perpendicular to the direction of the maximum horizontal stress, that is, σ_x is the maximum horizontal stress and σ_y is the minimum horizontal stress, thus $\sigma_x=30$ MPa and $\sigma_y=20$ MPa. According to the accident site survey, the distance from the coal was 2 m, that is, l=2, and the length along the roadway strike was assumed to be 2 m, that is, a=2 m. Referring to literature [35, 36], we get the tensile strength σ_T of the coal seam No. 5 of Tangshan Coalmine is 2.4 MPa, internal friction angle φ is 20°, and cohesion *c* is 1.8 MPa.

When the roof rebounds, N decreases, causing f_1 and f_2 to decrease or even to zero. Substituting all the parameters into the Eq. (3), the right side of the equation is calculated to be 19.4 MPa, which is less than 30 MPa on the left side of the equation. As a consequence, coal block A becomes unstable and rushes into the roadway, causing rockburst.
