Journal of Engineering Science and Technology Review 14 (6) (2021) 35 - 42

Accident Analysis of the Roadway Rockburst in Tangshan Coal Mine of China

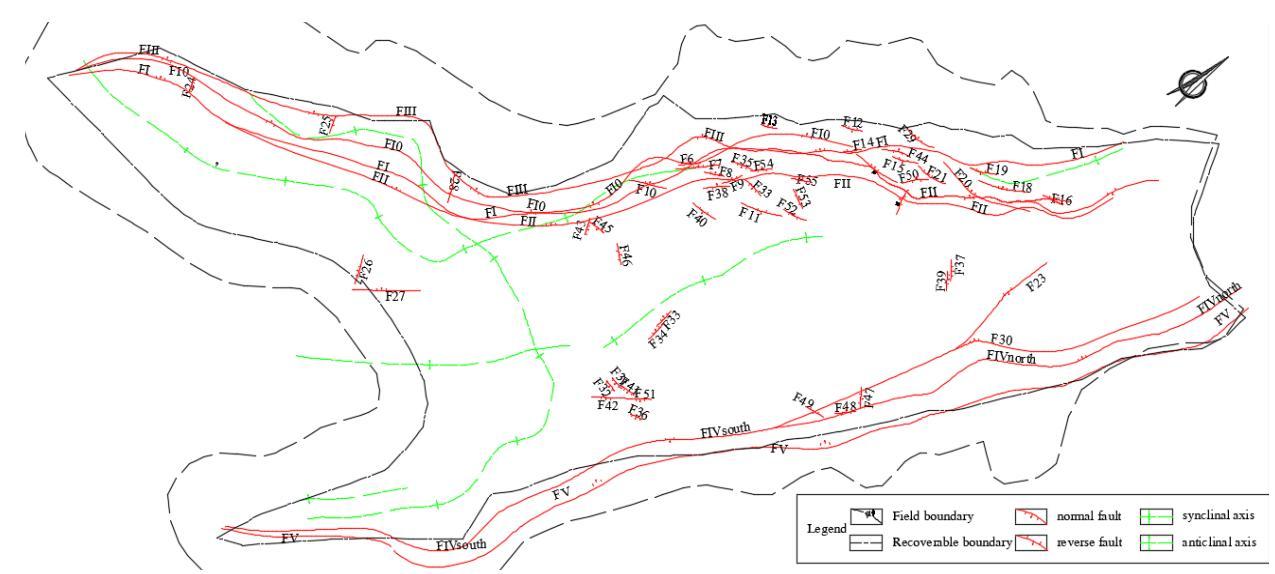
Fig. 1. Outline of the geological structure of Tangshan Coal Mine.

As a consequence, the geological structure of Tangshan mine is also complicated. The coalmine is located at the southwest rim of the northwestern wing of the Kaiping Coalfield, and the strata trike NE-SW. Most of the main structures in the coalfield are parallel to the stratigraphic strike, and the main faults, namely, FIV, FV are sequentially lied from north to south, and their strikes are basically parallel to the stratigraphic strike (Fig. 1).

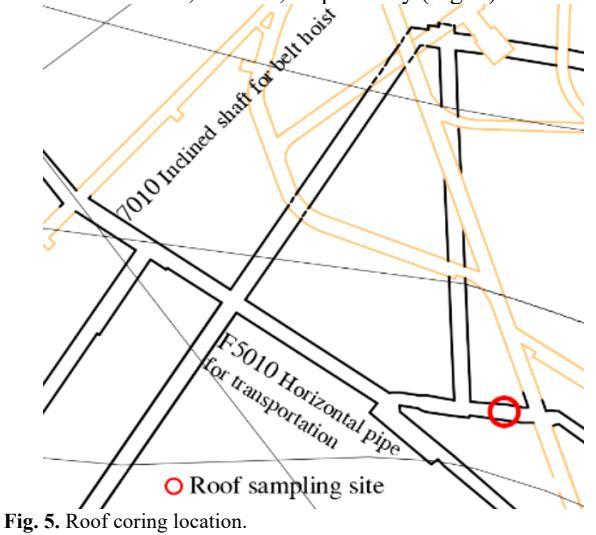
In order to ascertain the structure of the overlying strata above the coal seam No. 5 in Tangshan Coalmine, the roof sample coring approach was adopted. The roof sample coring was conducted at the horizontal transportation pipeline F5010 which is outside of the accident site. The diameter, depth, inclination angle of the drilled hole were 110 mm and 40 m, and 30° , respectively (Fig. 5).

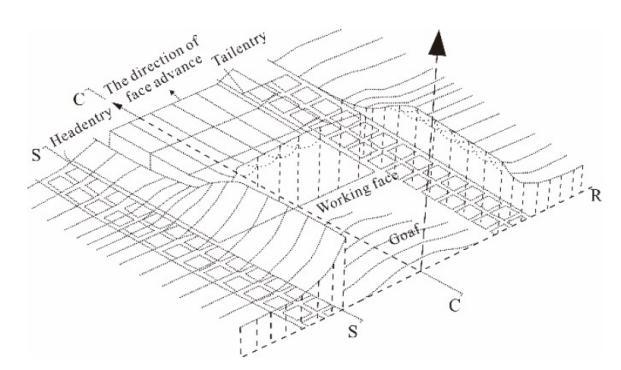
Fig. 8. Abutment pressure distribution around the working face [28].

Abutment pressure can be generated by roadway excavation and insufficient roof caving. The abutment pressure generated by the suspended roof that has not been fully caved over mining of this working face mainly acts on the coal in front of the working face. If the roof is not caved inadequately after the mining of the adjacent working face, the un-caved roof above the roadway will produce abutment pressure, which possibly affect the tailgate of the working face. After the supporting pressures of the two working faces are superimposed, the coal at the corners of the goaf side roadway in this work faces the highest vertical stress. The vertical pressure distribution around the entire working face is illustrated in Fig. 8 [33].

The accident site mentioned above is located at the border of the peninsula-shaped coal pillar, surrounded by irregular working faces that have been mined, and close to the terminal line of the F5009 working face. According to the accident survey report, the roof of the coal seam No. 5 is a hard rock stratum that is not easy to cave. This likely caused a large area of the suspended roof, forming a cantilever beam structure and making the coal in front subjected to higher abutment pressure.

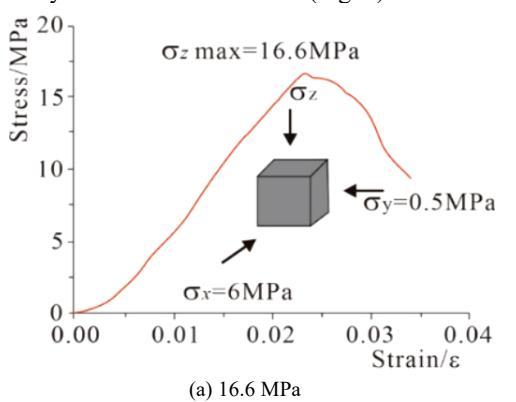
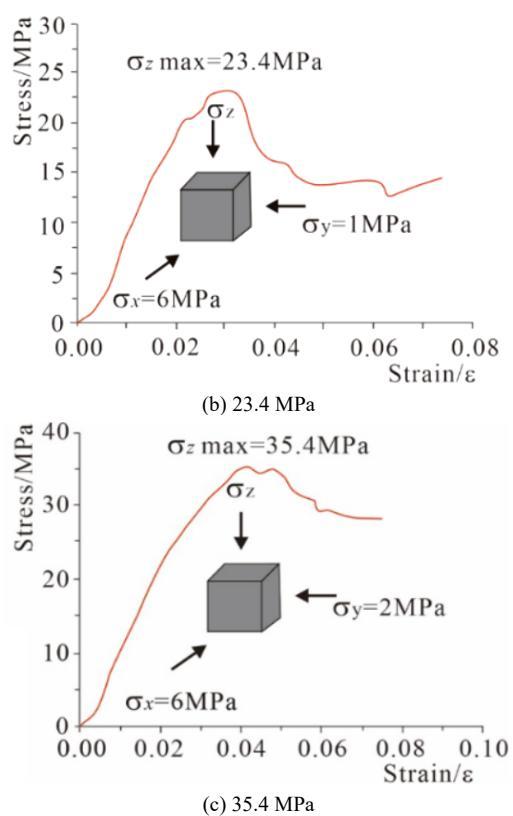
Fig. 9. Coal bearing capacity promoted with confining pressure [39].

When confining pressure is present, the bearing capacity of coal can be increased significantly. Substantial true triaxial experiments have shown that the coal peak strength will increase following a power function of the confining pressure. For instance, under true triaxial conditions, a horizontal stress (σ_x) applied to the coal sample was kept at 6 MPa and the other horizontal stress (σ_y) were assigned to 0.5 MPa, 1.0 MPa and 2.0 MPa, respectively [34]. The peak compressive stress (σ_z) deforming the coal sample reached 16.6 MPa, 23.4 MPa, and 35.4 MPa, respectively. Although the confining pressure was only increased by 0.5 MPa and 1.5 MPa, respectively, the compressive strength was increased by 6.8 MPa and 18.8 MPa (Fig. 9).
